## Design for Deconstruction and Reuse: Case study Villa Anneberg

**Innovative Design for the Future – Use and Reuse of Wood Building Components**

RISE rapport 2021:96

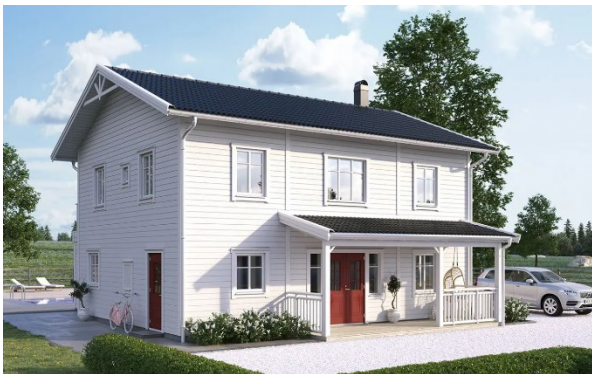
**Figure 3 Villa Anneberg. Image: Derome**

The object of the case study is, as mentioned earlier, a concept house from Derome: Villa Anneberg (Figure 3). It is a two-storey, single family residential building. The frame consists of prefabricated, insulated planar stick frame elements mounted on a concrete slab.

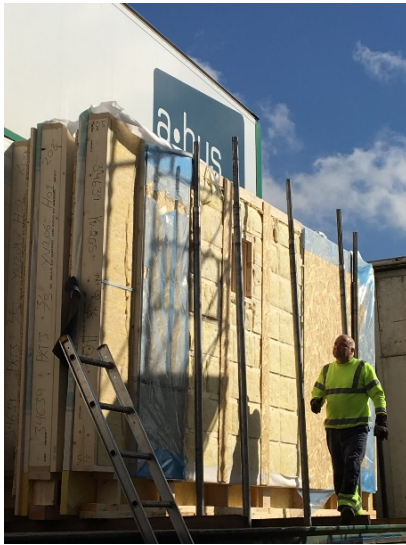
**Figure 5 Exterior wall elements.**  
**Image: Derome**

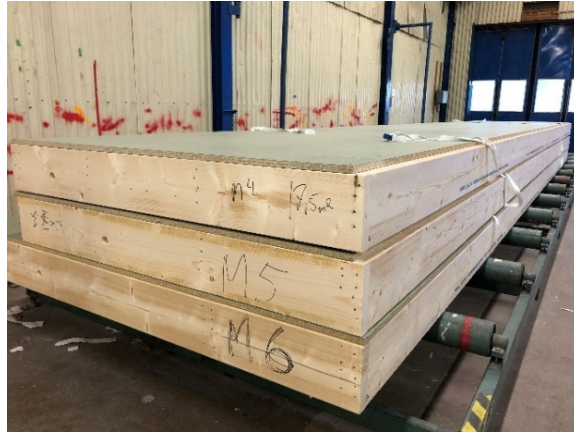
**Figure 6 Floor elements (cassettes).**

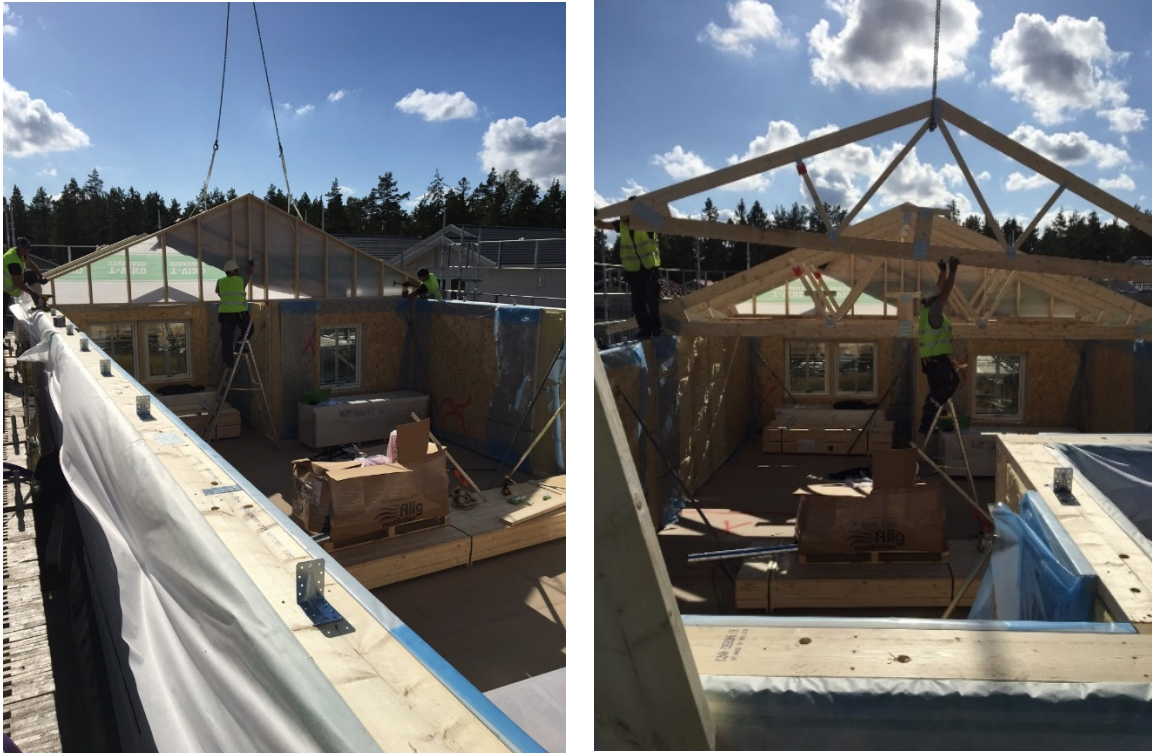
**Figure 9 Angle brackets connect roof trusses to walls. The photos show roof trusses being installed. In this specific case, the assembly team has mounted the angle brackets before mounting the roof truss. Images: Derome**

Roof trusses are connected to the top plates of the exterior walls with screws and angle brackets (Figure 9).

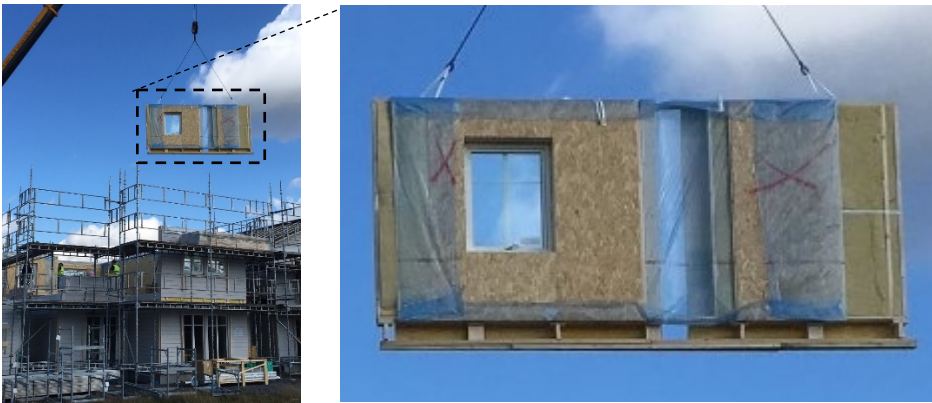
**Figure 11** Exterior wall panel lifted in place during assembly, ends are left open to allow for screwing. Image: Derome

To that end, part of the panels are left open during assembly (Figure 11).

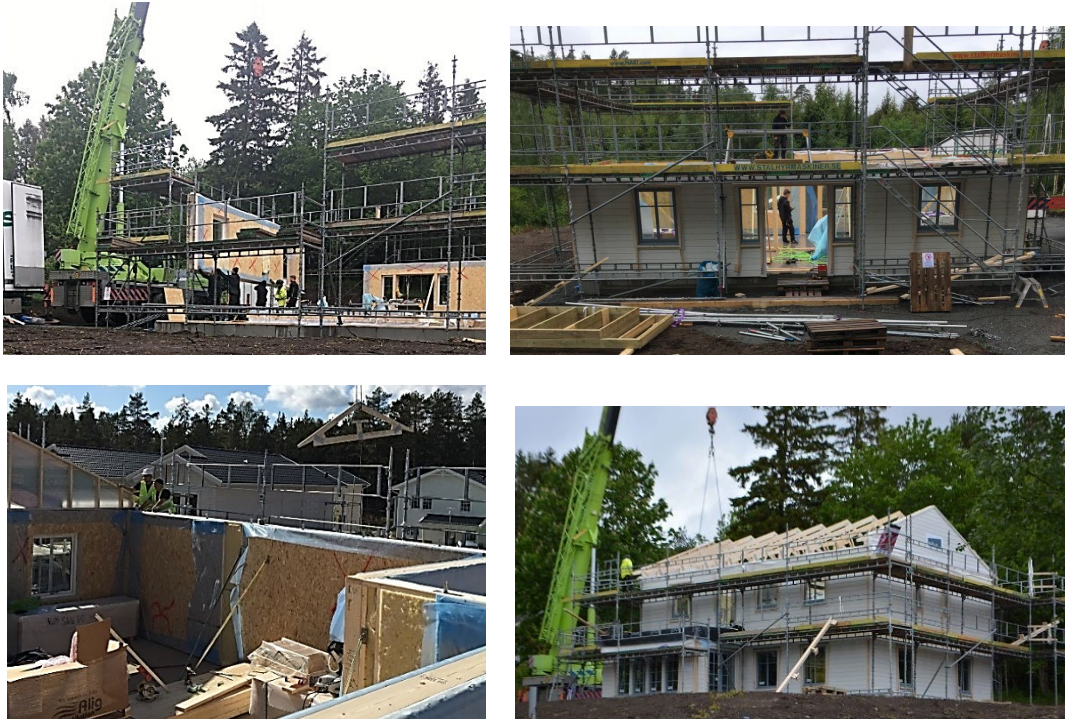
**Figure 13 Assembly of a Villa Anneberg. Image: Christin Ljungqvist and Derome (bottom left)**

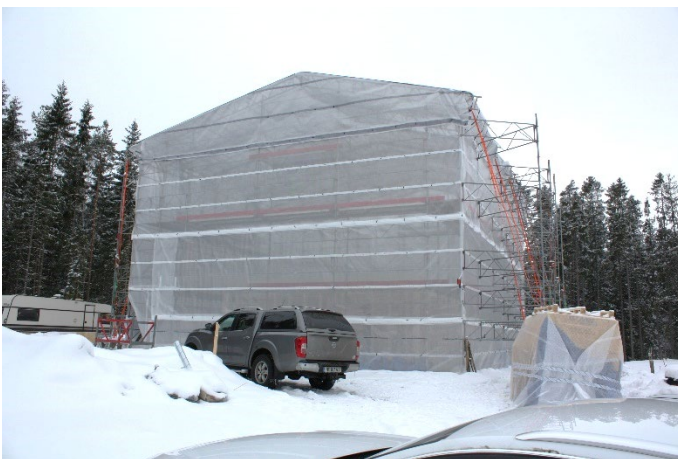
***Figure 14 Weather protection. Methods and instructions for weatherproof deconstruction needs to be developed. Image: Andreas Videll, Derome***

Methods and instructions for weather protection during deconstruction (example, Figure 14) could be developed to make sure that there is no risk for moisture damage.

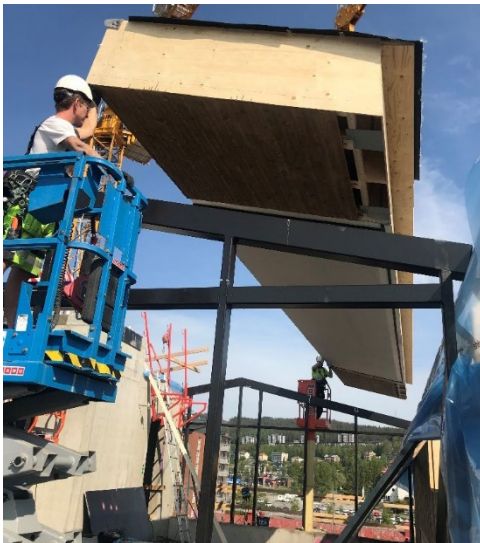
**Figure 15 Roof cassette, example. Image: Lättelement AB**

The building could be designed with roof cassettes; members that are both loadbearing and insulating (Figure 15). Roof cassettes, unlike roof trusses, do not need temporary bracing during erection and deconstruction. The risk that assembly teams add superfluous connectors is probably smaller for this type of structure than for roof trusses. After deconstruction, the entire cassette can be reused, and no boarding will go to waste. The cassettes are robust and easy to handle in deconstruction and transport, which should reduce time and energy consumption compared to handling roof boarding and roof trusses. In summary, time, waste, and risks should be reduced by building with roof cassettes.

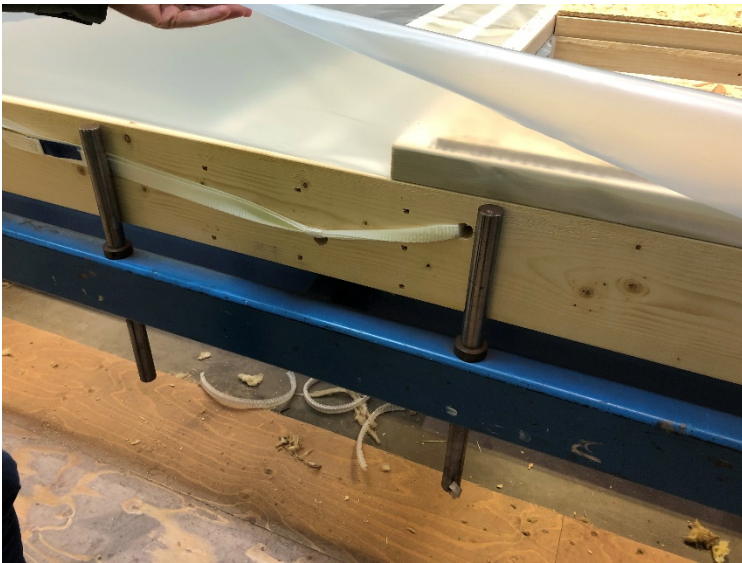
***Figure 16 Lifting loops like this might possibly be left in the mounted structure, but this would have to be studied.***

It could be studied further if lifting loops used in primary construction (Figure 16) could systematically be left within in the walls, without causing problems such as gaps between wall and floor. The loops could be reused if deconstruction took place in a few years. If the loops have reached an age of several decades, it might be necessary to replace them but having the original ones in place should simplify the replacement.

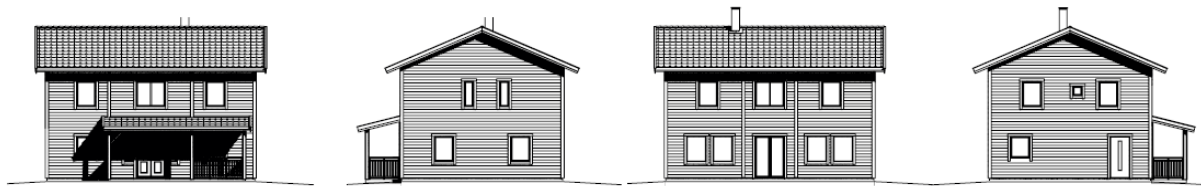
**Figure 24 Elevations**

Some elevations and layout plans are presented in Figures 24 and 25.

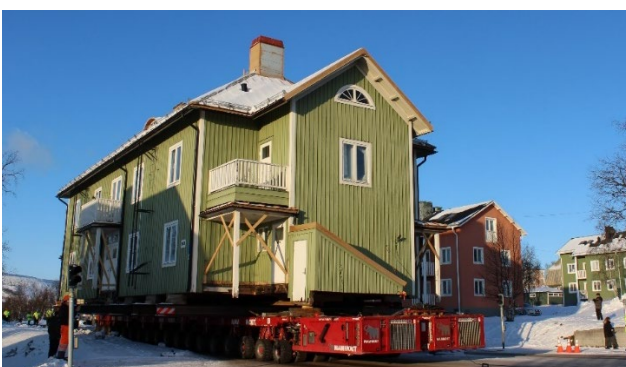
**Figure 32 Buildings can be moved in their entirety as an alternative to demolition. The photo shows a two-storey timber building being moved in Kiruna. Image: Kiruna municipality**
